Bulletin of the Geological Society of Greece

Vol. 43, 2010

THE POTENTIAL NATURAL HAZARDS TO BE CONSIDERED IN THE DESIGN AND EXPLOITATION OF THE AERIAL ROPE-WAY IN THE “GORA SOBOLINAYA” MOUNTAIN-SKIING RESORT (SOUTHERN PRIBAIKALIA, RUSSIA)

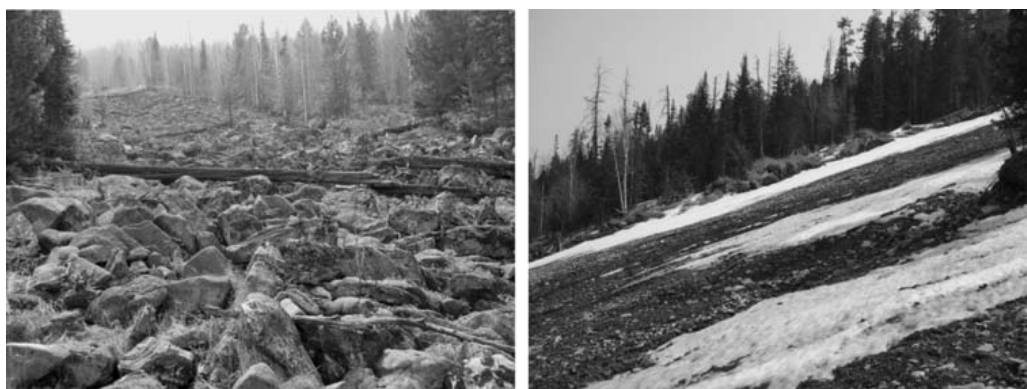
Fig. 4: Geological processes developing within the area of lifting system route: stone stream (left); ground ablation (right).

The pole N8 is located on the technogenically disturbed slope with graded surface, removed sod cover and stripped deluvial deposits and intensive ground ablation. The foundations for poles N9, N10 and N11 are located on the 40° slope. The poles N10 and N11 are located within the area of stone river with outcropping coarse rock debris of relatively equal size (~1.5-2.0 m across) in the centre of stone field, and grassed and bushy perimeter area (Fig.4). The stone field is stable, without any sign of movement (rock walls, fractures, zones of bleaching). The coarse rock debris insulate the bedrock surface from the solar radiation, saving the low temperature in the area of stone field and hindering the ground defrosting rate. High permeability of rock and the near-surface location of frozen rocks promote the intense downhill runoff of thawing water across the stone field body. Besides, the bushy surface of the stone field's lower edge is the evidence of its stability.

In the area of pole N12 (above the 700-710 m a.s.l. elevation marks) the slope steepness exceeds 40°, reaching in places 47°. The lack of sod cover is the cause of intensive downhill ground ablation that starts with the snow thawing; the intensity of ground ablation depends upon the thickness of snow cover and slope steepness. In the case of simultaneous snow thawing and excess raining, the rates of defrosting and intensity of ground ablation increase, entailing the erosion and dissection of the re-
